Hydrogen in Gas Grids

A systematic validation approach at various admixture levels into high-pressure grids

D4.4

Final report on systematic validation of testing loop

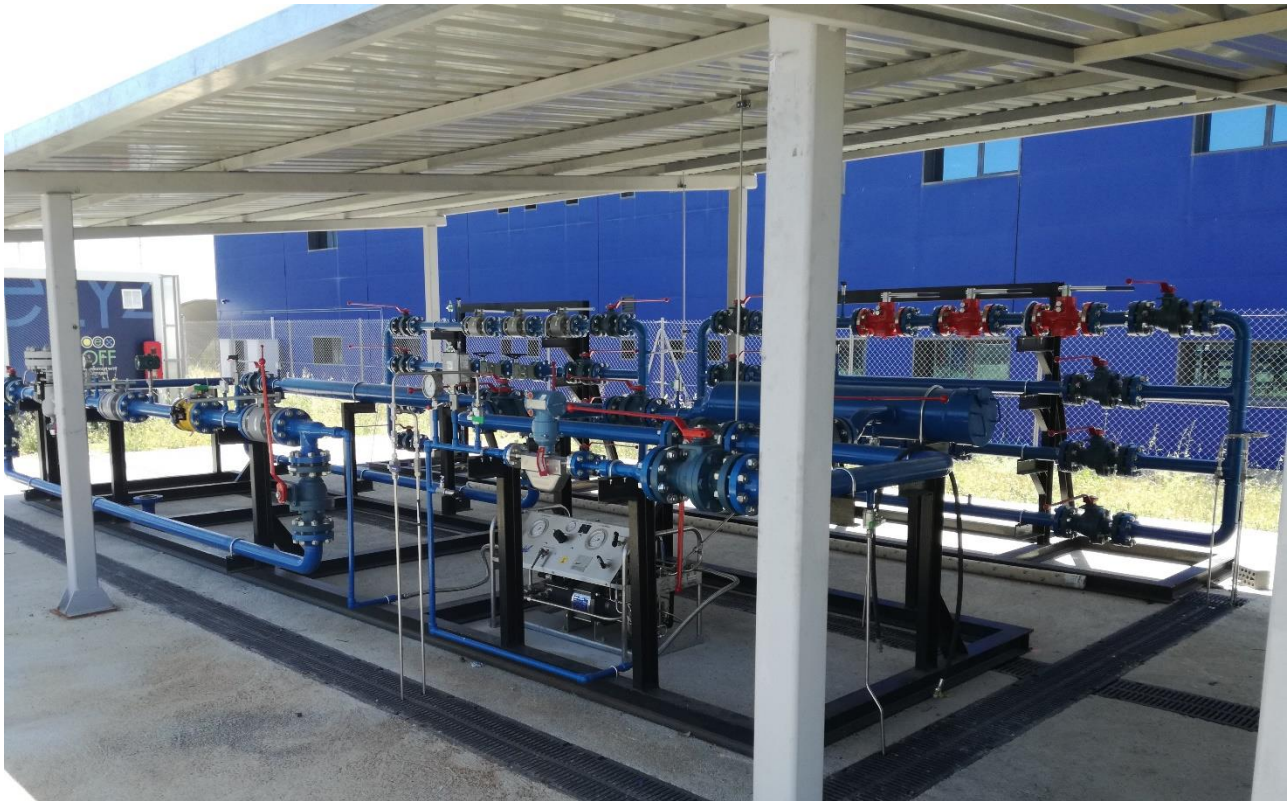
Figure 1. Picture of HIGGS experimental platform at Aragon Hydrogen Foundation (FHa, Spain)

The R&D testing platform designed and built in the frame of the HIGGS project, consists of a static section, a dynamic section, and a membrane prototype. A picture of this facility can be seen in Figure 1. The static section is the part of the facility where the tightness of valves is studied. In the dynamic section, the impact of hydrogen on the material integrity of pipes and equipment is assessed. Finally, gas separation tests are performed with a membrane prototype to recover hydrogen from the high-pressure blend.

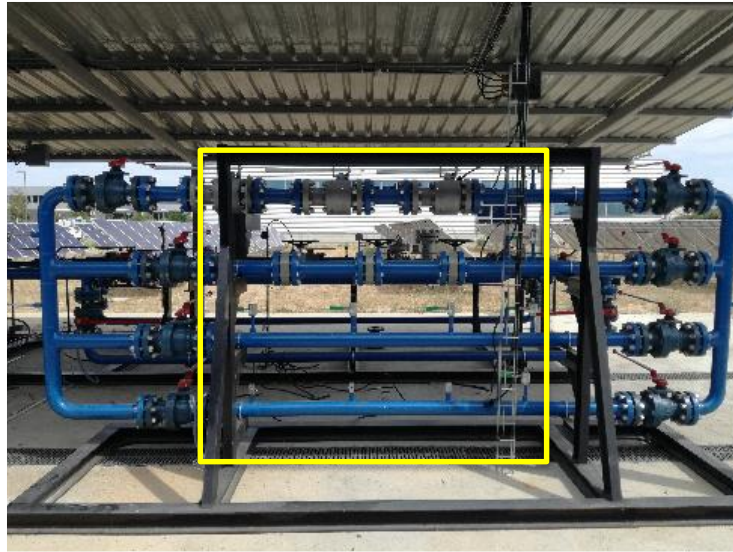
Figure 2. Picture of the valves testing section

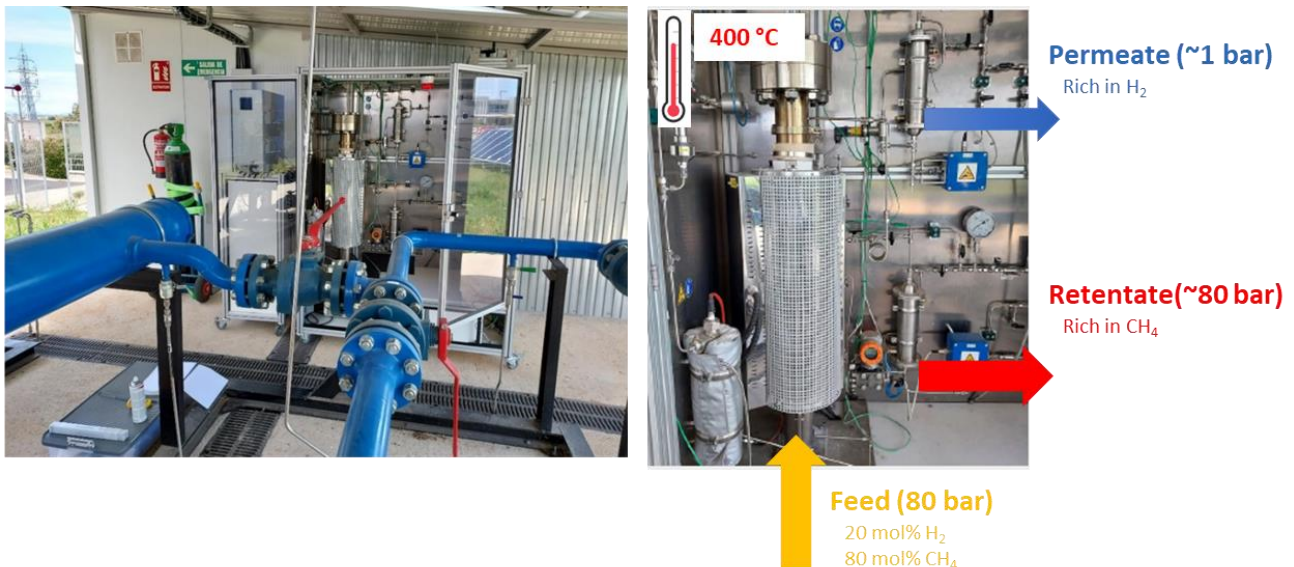
Figure 3. Gas separation prototype

The prototype consisted in a feeding line as inlet and two outlets (permeate and retentate). The permeate was the stream rich in hydrogen, and the retentate, rich in methane, Figure 3. A back-pressure regulator was placed at the outlet of the retentate side to set the required trans-membrane pressure difference. The retentate and the permeate lines were connected to the analysis section with mass flow meters, to measure and monitor the permeate and retentate flows.

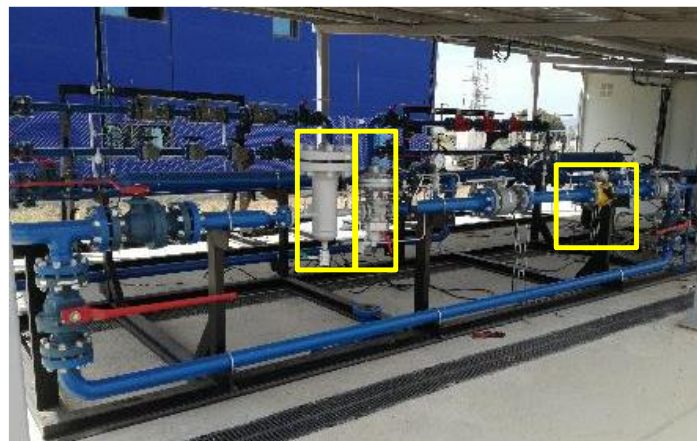
Figure 4. Picture of the testing equipment in the dynamic section

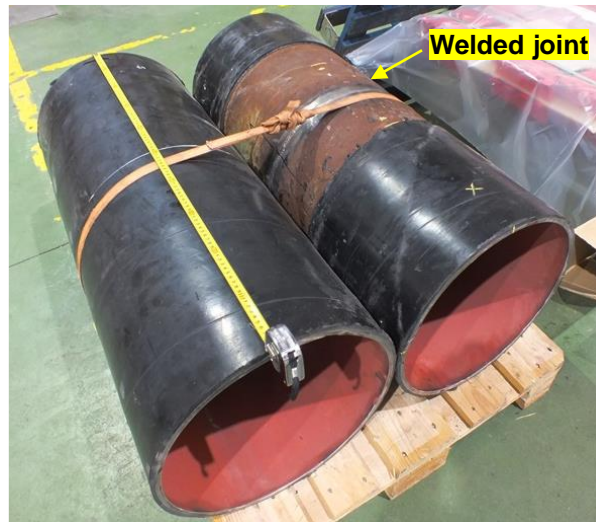
Figure 5. Detail of sections of the API 5L X70 steel pipes upon reception in Tecalia

Hydrogen embrittlement tests were carried out on API 5L [2] qualities grades X42, X52, X60 and X70. A picture of the API 5L X70 steel pipes under study is given in Figure 5. The chemical composition, mechanical properties and metal microstructure of the as received base and welded steels were characterised. It is important to note that the API 5L steels under study are new materials, this is, they have not been in service. Table 4 summarises important aspects of the steels under study. The heat affected zone (HAZ) and weld metal regions corresponding to a X70 steel welded joint are shown in Figure 6, together with the hardness evolution in the above-mentioned regions.

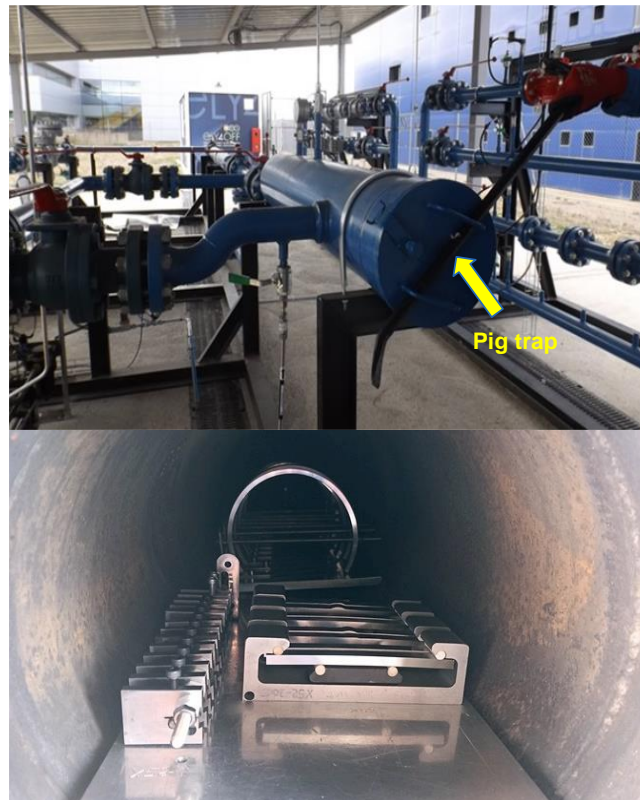
Figure 7. Picture of the pig trap (up) and the constant strain specimens allocated inside it (down)

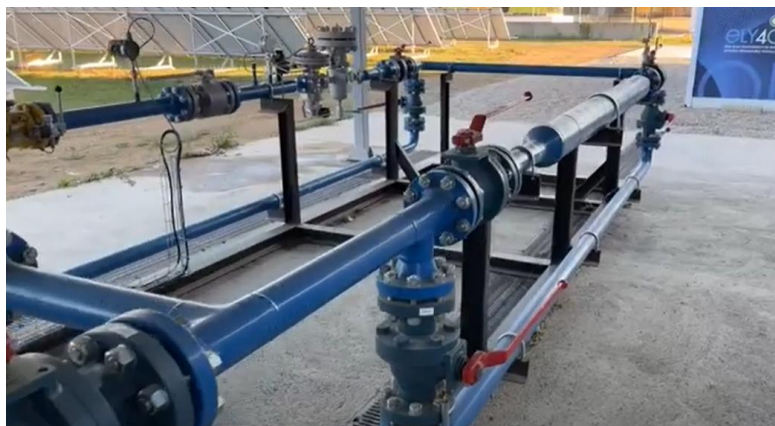
Figure 8. Welded pipe sections of the API 5L steel pipes

Some sections of the API 5L steel pipes grades X42 to X70 under study were welded to each other following the GTAW procedure and installed in the R&D facility at FHA (Figure 8). The objective was to check the effect of hydrogen on both, the welded and the parent material, after the approximately 11000 hours of exposition to the different hydrogen concentrations used in the four experimental campaigns carried out.

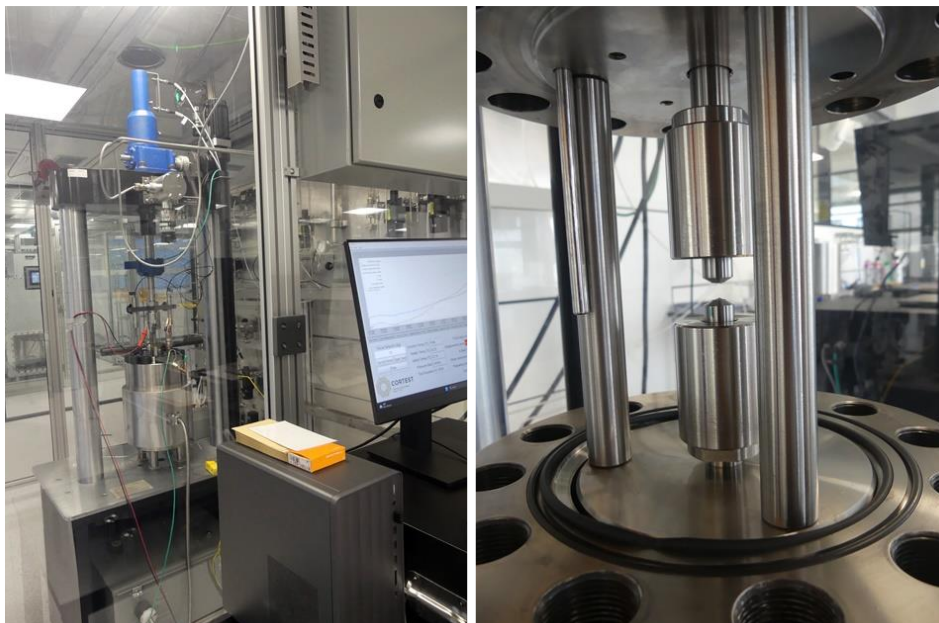
Figure 9. SSRT, fracture toughness and fatigue machine for testing in H₂ gas (left). Detail of fractured notched specimen (right)

Figure 9 shows a detail of the SSRT, fracture toughness and fatigue machine for testing in H₂ gas. A picture of the notched tensile specimens used in HIGGS is shown in Table 6. The stress concentration factor (K_t) due to the notch in the (base) notched specimens is 4.6. K_t is defined as the ratio between the peak stress at the root of the notch, and the nominal stress which would be present if a stress concentration did not occur.

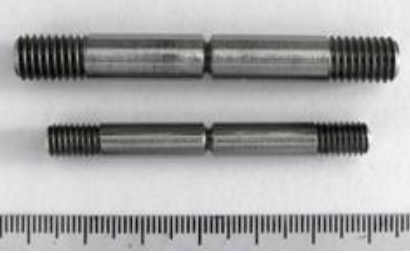
Type of specimen	Rising load test
	SSRT
Geometry

Notched tensile specimens
Applicable standards	ASTM G142/G129, ISO 7539-7 [11]
Atmosphere	100 mol% H ₂
Pressure	80 bar
Test duration	7-14 hours
Post testing evaluation	<ul style="list-style-type: none"> ➤ Reduction of Area (RA); Ratio RA (RRA) ➤ Notched Tensile Strength (NTS); Ratio NTS (RNTS)
Advantages	<ul style="list-style-type: none"> ➤ Material screening method ➤ HEE indexes could be established based on the RA and NTS ratios

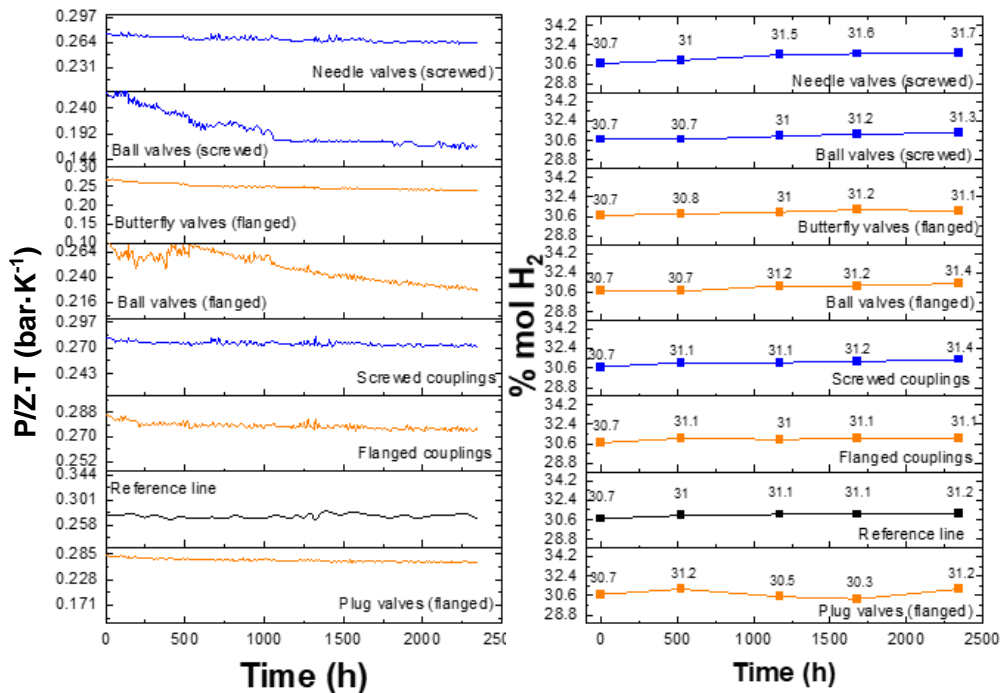
Figure 12. Evolution of the pressure P/Z·T quotient (left) and H₂ gas composition in each line of the static section during the 3rd experimental campaign (30 mol% H₂+ impurities of H₂S and CO₂)

Similar to what was observed in the 2nd experimental campaigns, a slight increase in H₂ concentration was detected as the test advances. However, the increase is not high enough to assume that hydrogen stratification in the line, was occurring.

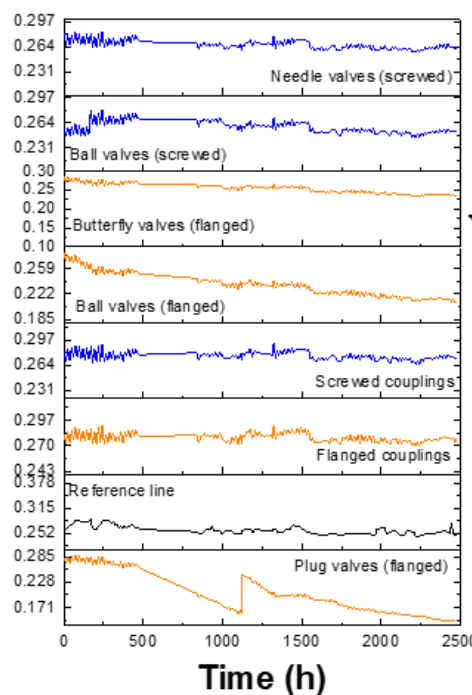
Figure 13. Evolution of the pressure $P/Z \cdot T$ in each line of the static section during the 4th experimental campaign (100 mol% H₂)

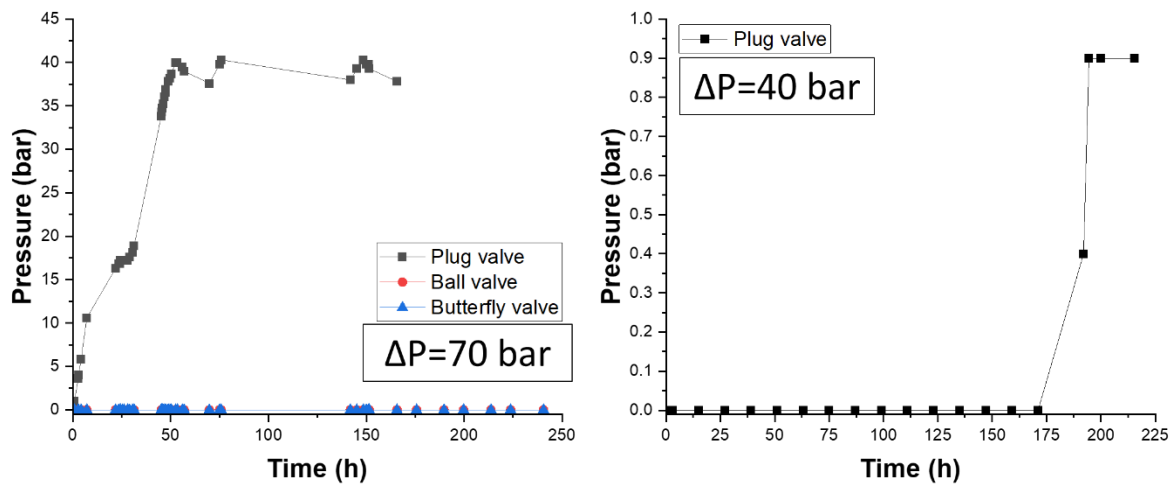
Figure 14. Pressure against time during the internal tightness test at $\Delta P=70$ bar (left) and $\Delta P=40$ bar (right)

An additional test was performed with the flanged valves to check their internal tightness, when operating with 100 mol% hydrogen. Just one plug, ball and butterfly valve were selected for this test. At the beginning of the test, hydrogen was fed at 70 bar to one side of the valve and the other side was left at atmospheric pressure. The pressure evolution was monitored at the low-pressure side during several hours.

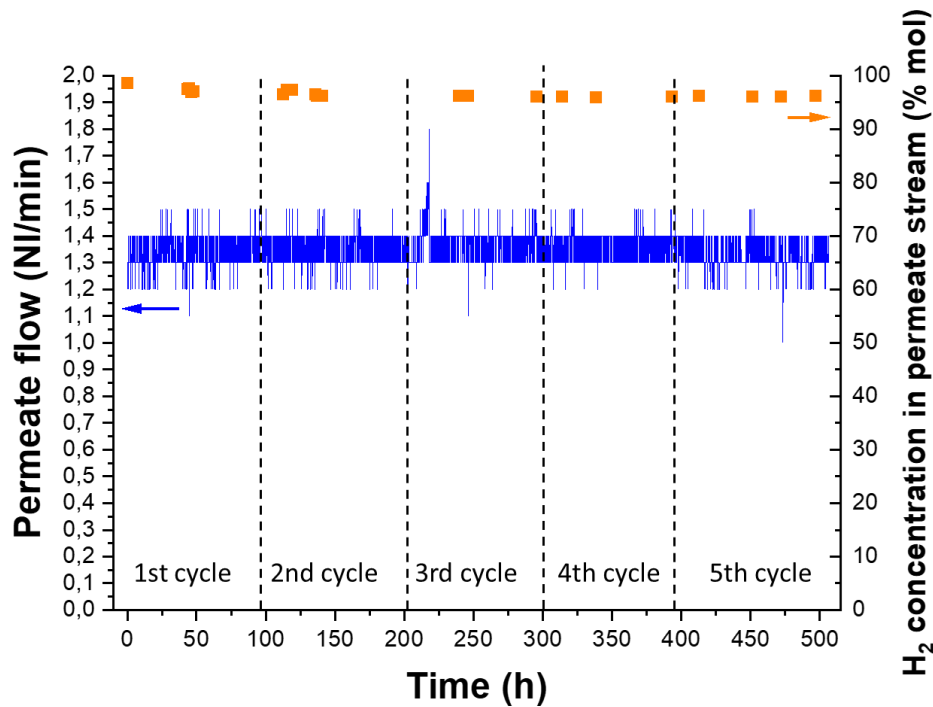
Figure 15. Gas separation performance of the prototype with Membrane #1. Blue line stands for the total permeate flow and orange scatter stands for the H₂ purity in the permeate stream

The permeate flow (rich in hydrogen) has been monitored and its composition analysed periodically during the different cycles of the test. Figure 15 shows how the permeate flow remains mainly constant during the whole operation, with an average value of 1.35 ± 0.06 NI·min⁻¹. The hydrogen content in the permeate stream is of 98.6 %mol at the beginning of the test but, decreases gradually from the second cycle on. Its values are anyway always above 96.0 %mol. The retentate stream can be calculated with a mass balance because the composition of the feed and permeate flows is known. A retentate flow of 6.93 to 7.03 NI/min⁻¹ with a hydrogen content between 3.5 and 5.7 %mol can be calculated. The CH₄ content in the retentate flow (between 94.3-96.5%mol) may be sufficient for end-users demanding a high natural gas quality. In any event, the CH₄ content in the retentate stream could be raised by increasing the membrane area if deemed necessary.

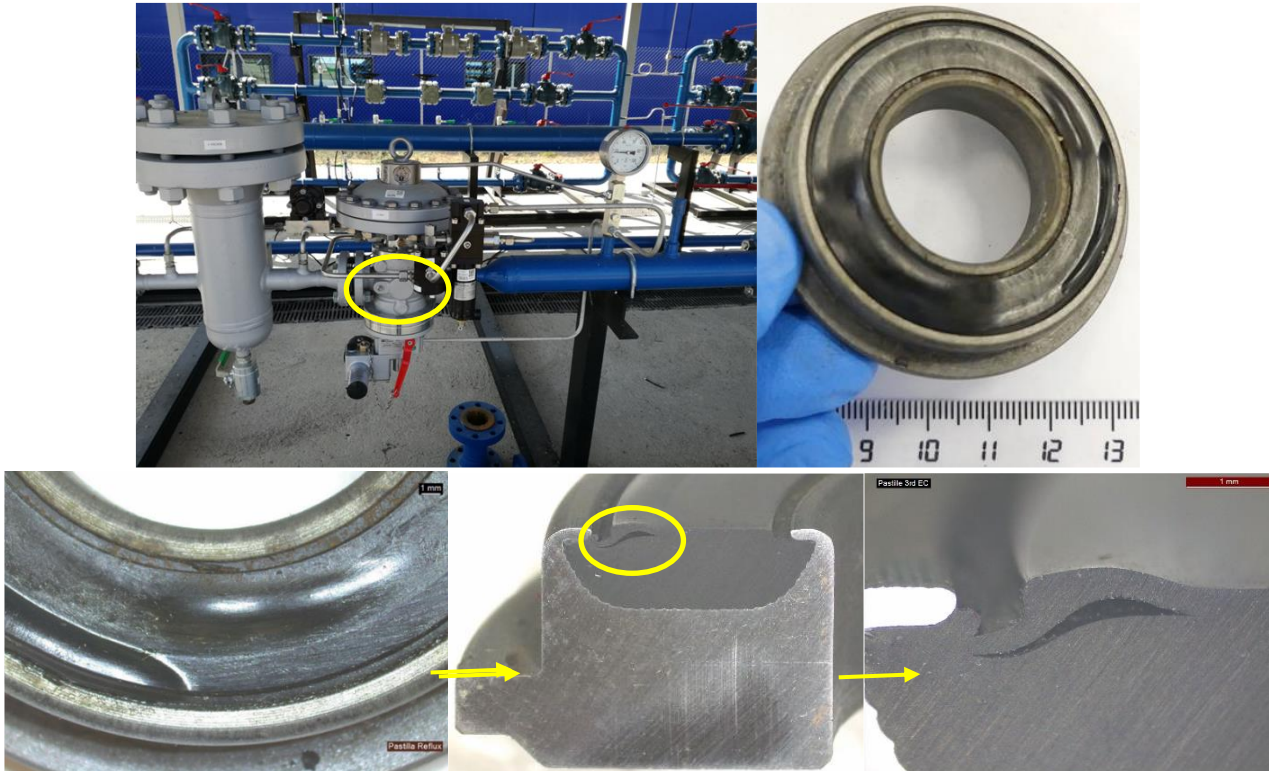
Figure 16. Pressure regulator and details of blistering in valve seat at the conclusion of the 3rd experimental campaign

Apart from linear or scratch abrasion in certain components, mainly generated in the process of disassembling, no clear signs of hydrogen damage were observed on the different parts inspected, except for the valve seat after the 30 mol% H₂ campaign (i.e. 3rd campaign), for which a significant blistering was observed, as shown in Figure 16. It should be noted that blistering was only observed for this component in this campaign and not observed in the 100 mol% H₂ campaign (Figure 17). There is therefore, no clear evidence of the influence of hydrogen on the observed damage, most likely due to a defect in the manufacturing of the component.

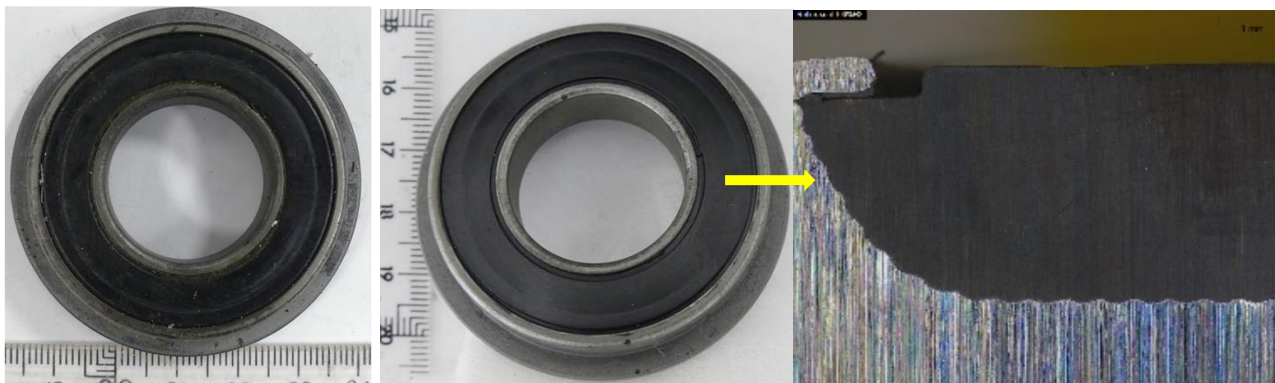
Figure 17. Valve seats tested at 20% H₂ + impurities of CO₂ and H₂S (left) and 100 mol% H₂ (centre, right). The valve tested at 100 mol% H₂ was cut to verify the absence of blistering or other type of damage

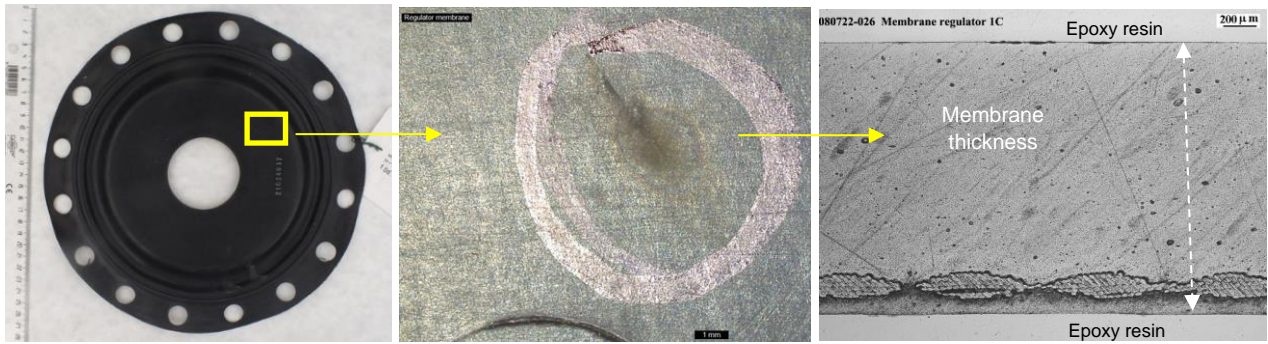
Figure 18. Parts of the pressure regulator after the 20 mol% H₂ exposure: membrane: general appearance (left), detail of area with unknown damaged area (centre) and cross section materialographic probe (right) showing a very superficial damage

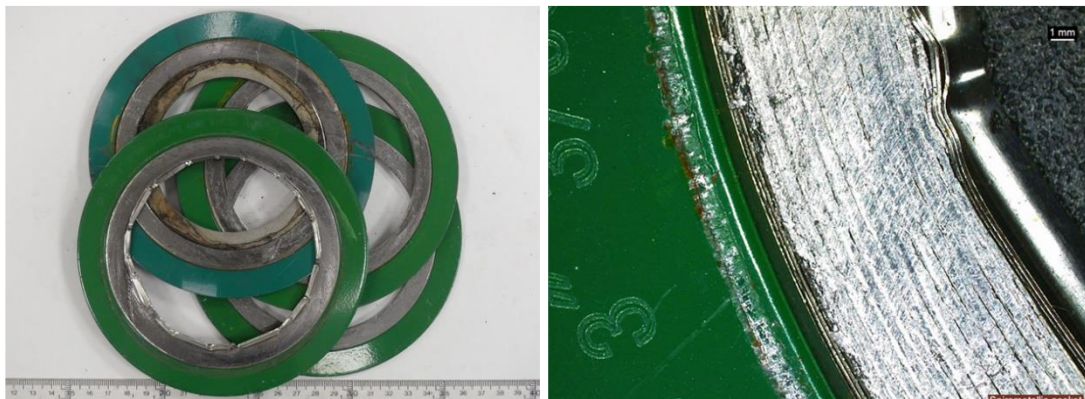
Figure 19. Spirometallic gaskets after the 20 mol% H₂ + of CO₂ and H₂S impurities campaign

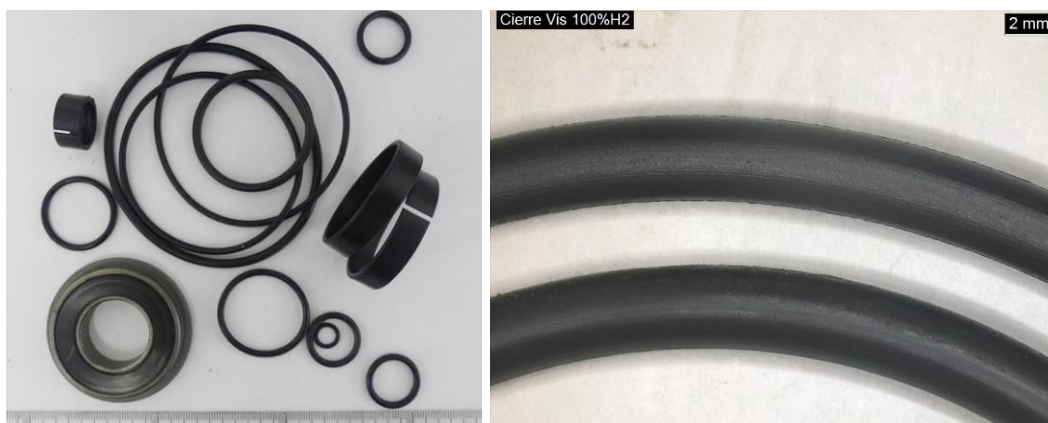
Figure 20. Parts of the pressure regulator (left) and detail of O-rings (right) after the 100 mol% H₂ campaign

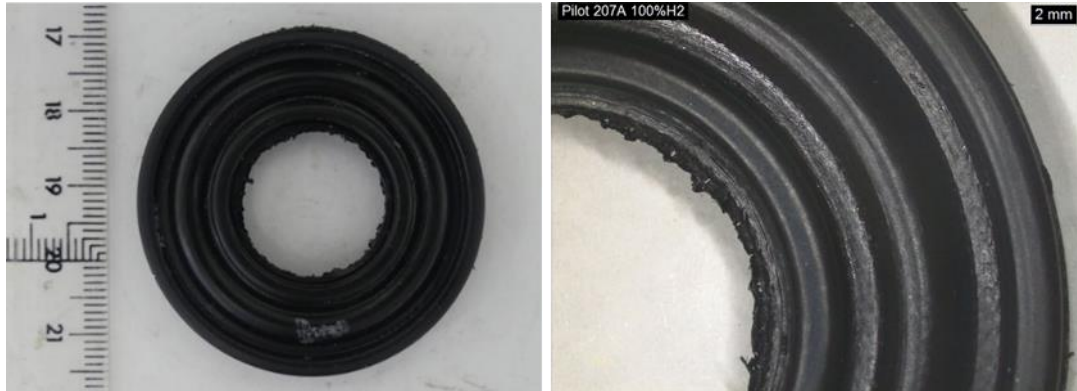
Figure 21. Detail of membrane from the pressure regulator after the 100 mol% H₂ campaign

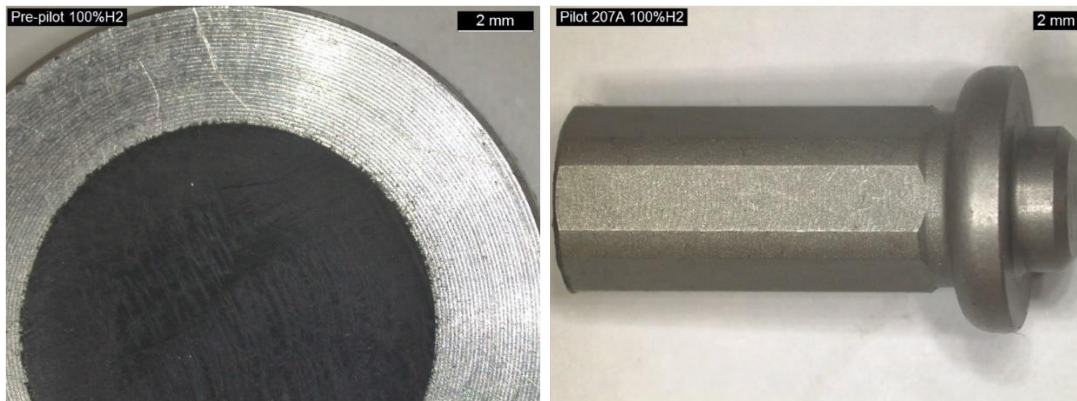
Figure 22. Metallic parts of the pressure regulator after the 100 mol% H₂ campaign

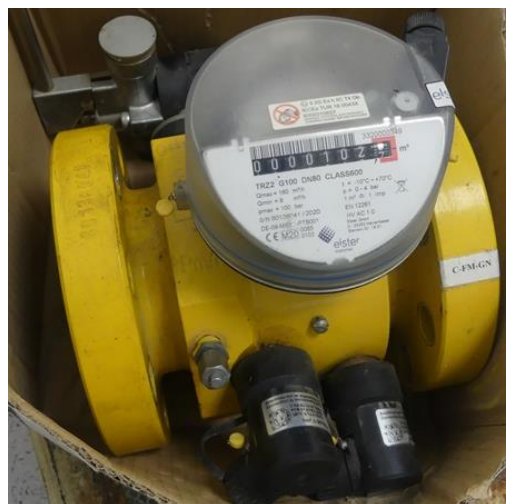
Figure 23. Detail of ELSTER TR22 G100 DN80 Class 600 turbine gas meter after the 100 mol% H₂ campaign

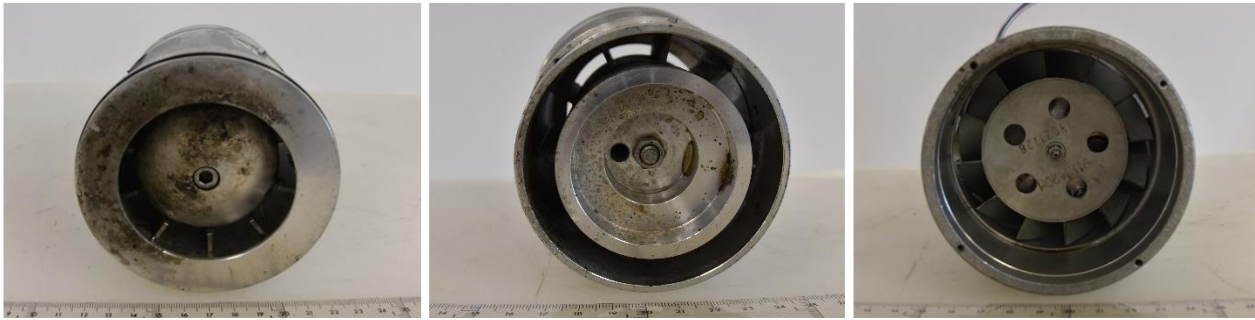
Figure 24. Detail of flow turbine gas meter bodies

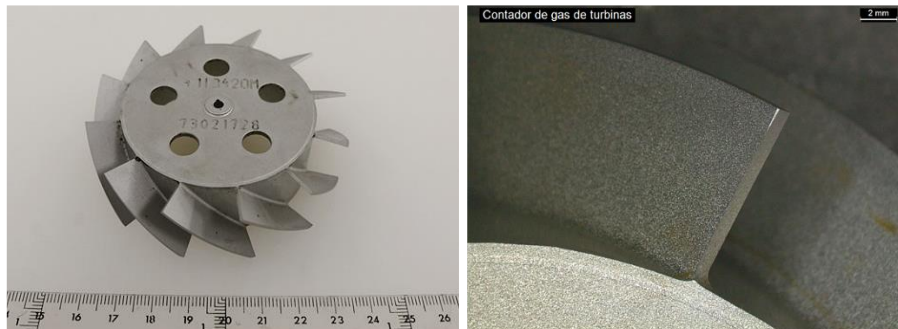
Figure 25. Aluminum gas meter rotor and detail of rotor blade

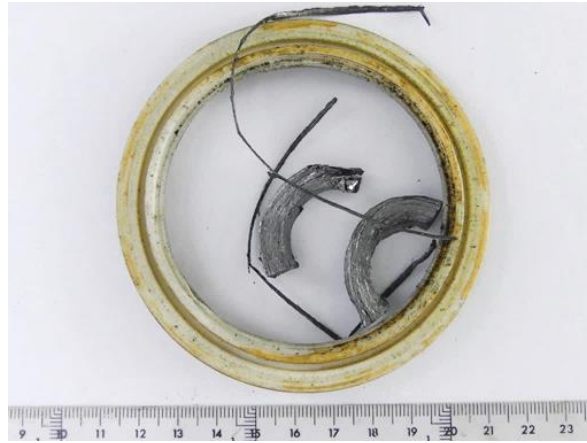
Figure 26. Components of the DIDTEK 600-3 valve showing detail of the graphoil and Teflon seals after the 100 mol% H₂ campaign

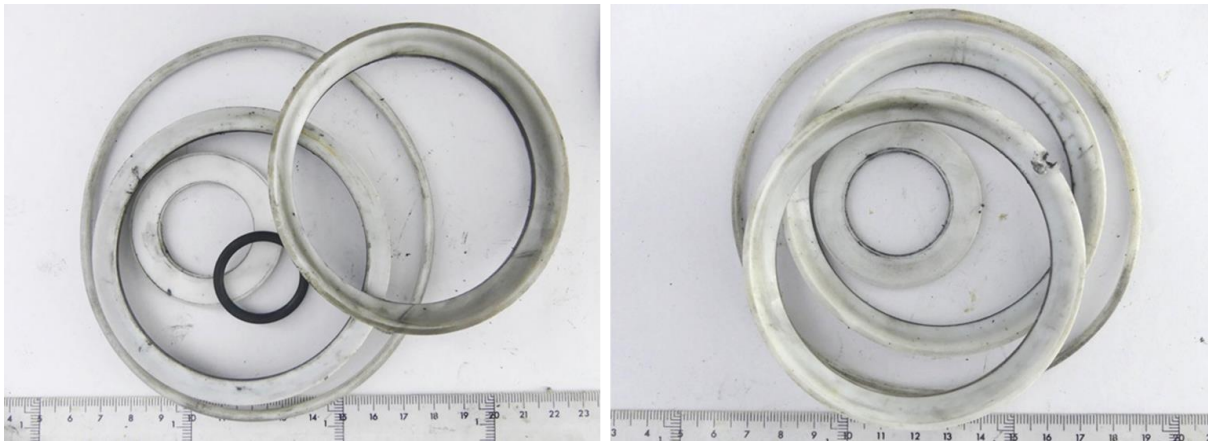
Figure 27. Components of the ALFA VALVOLE n° 5 (left) and ALFA VALVOLE n° 6 (right) Teflon seals after the 100 %mol H₂ campaign

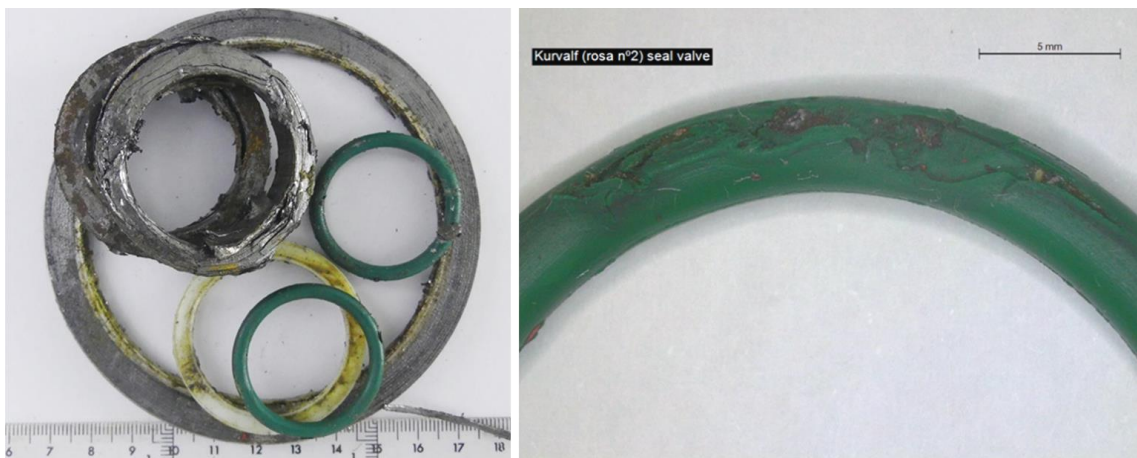
Figure 28. Components of the KURVALF rose n°2 plug valve and detail of O-ring after the 100 %mol H₂ campaign

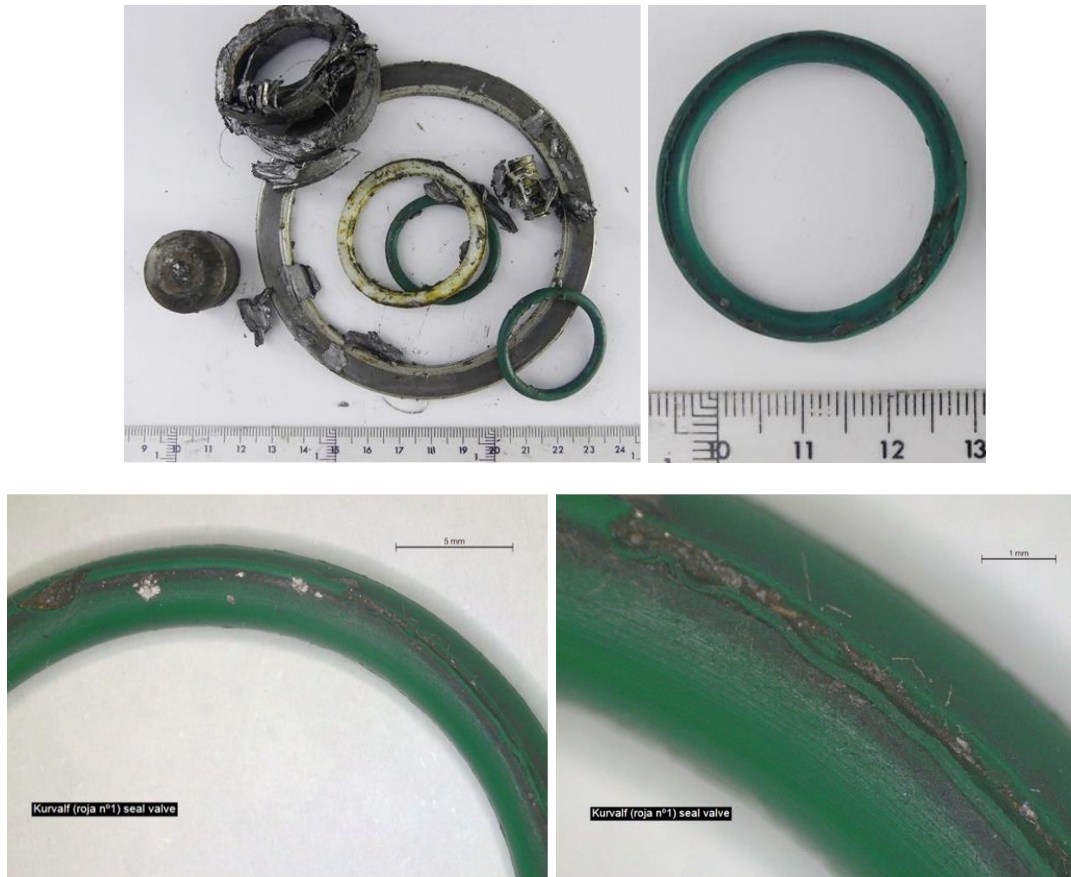
Figure 29. Components of the KURVALF red n°1 plug valve showing detail of O-rings after the 100 mol% H₂ campaign

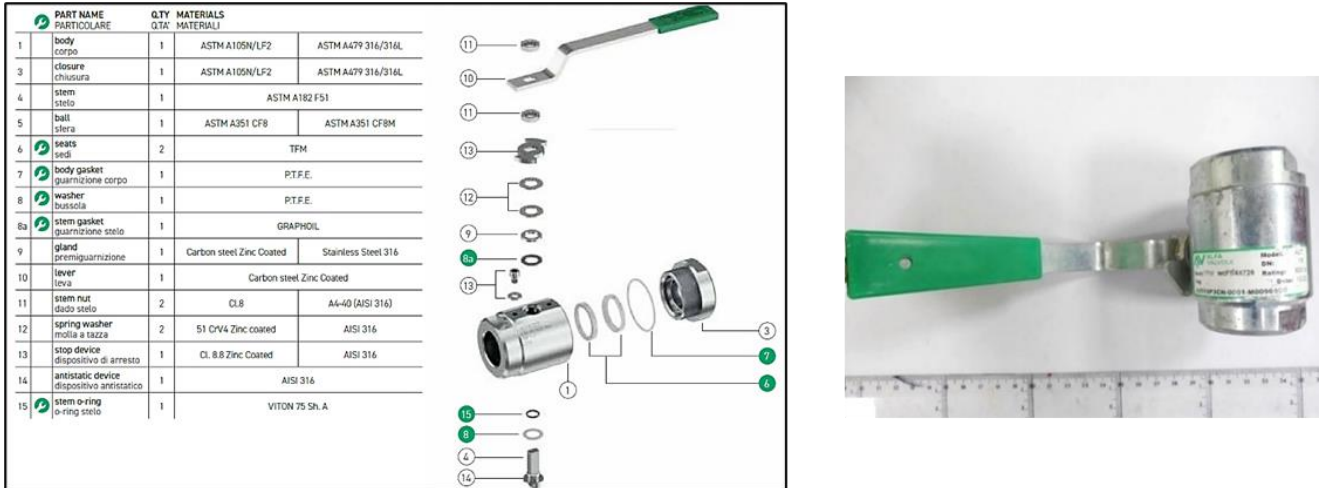
Figure 30. Photograph showing detail of the ball valve sent to TECNALIA (right) and data sheet supplied by the manufacturer (left)

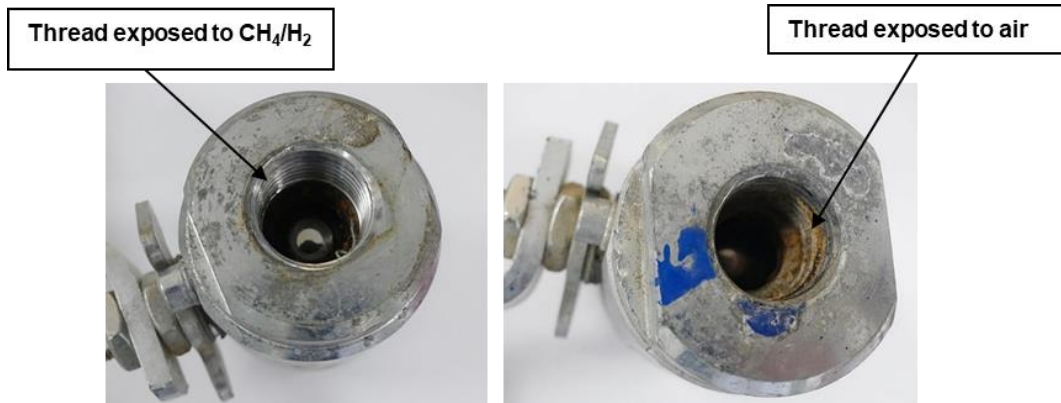
Figure 31. Photographs showing details of the ball valve

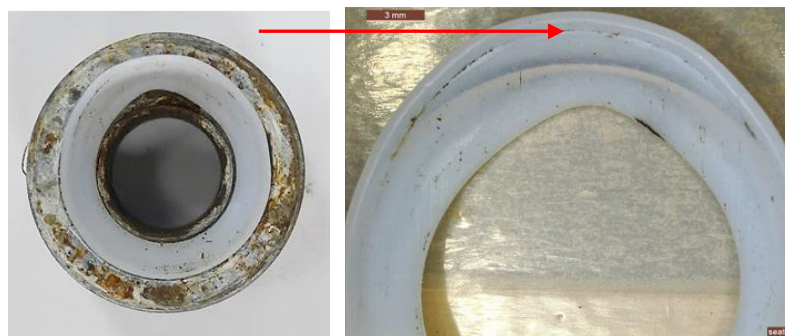
Figure 32. Photographs showing detail of the deformed TFM seat

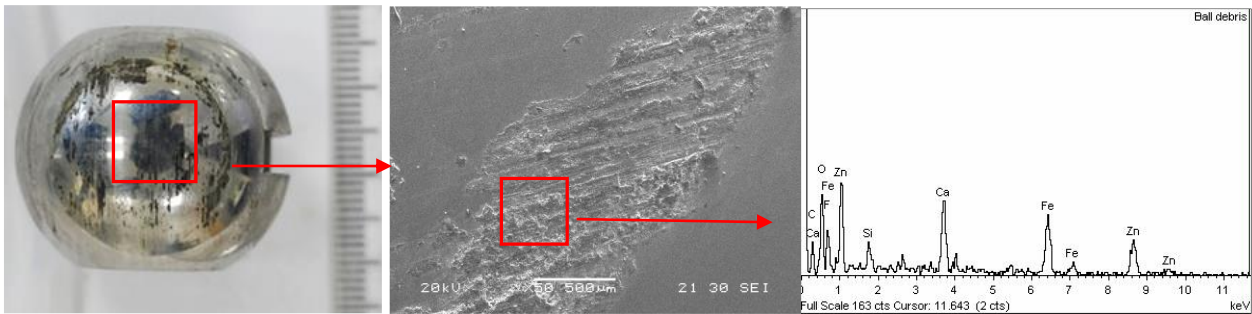
Figure 33. Photograph showing detail of the ball (left) and SEM micrograph of abraded area (centre) with EDS spectrum of this zone (right)

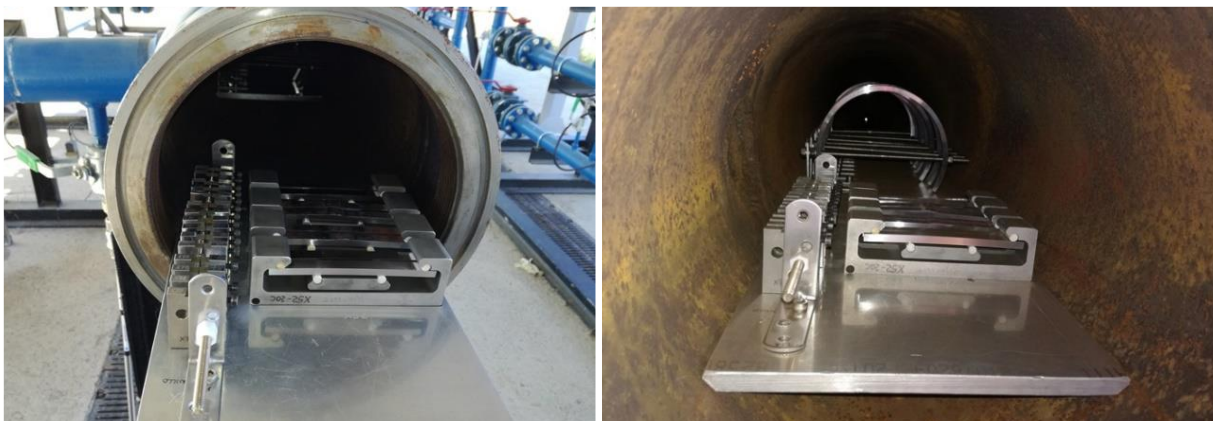
Figure 34. Test specimens inside the pig trap in the loop experimental platform at FHA at the beginning of the 2nd experimental campaign (left) and once concluded (right)

The constant displacement steel specimens were located inside the pig trap, in the loop experimental platform, at FHA and exposed to the different H₂ concentrations. At the conclusion of each experimental campaign, the dynamic section of the loop was depressurised and purged with nitrogen and the pig trap was opened. Figure 34 and Figure 35 show the aspect of the racks with the self-loaded steel specimens inside the pig trap, at the conclusion of the 2nd and 4th experimental campaigns, respectively.

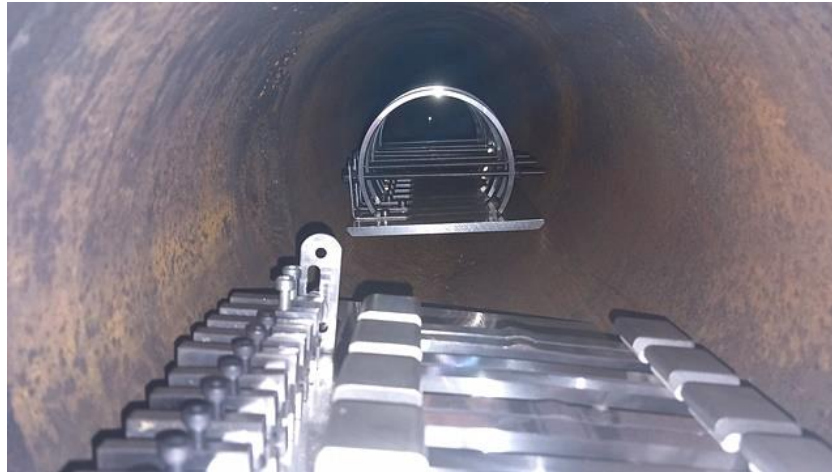
Figure 35. Test specimens inside the pig trap at the conclusion of the 100 mol% H₂ experimental campaign

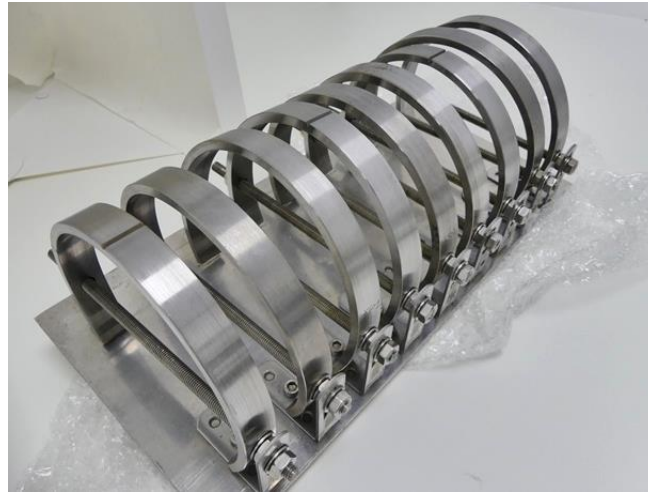
Figure 36. Detail of tested C-ring specimens after the 100 mol% H₂ campaign

The appearance of the tested C-ring specimens after the 100 mol% H₂ experimental campaign is given in Figure 36. Details of the metallographic evaluation are given in Figure 37 and Figure 38.

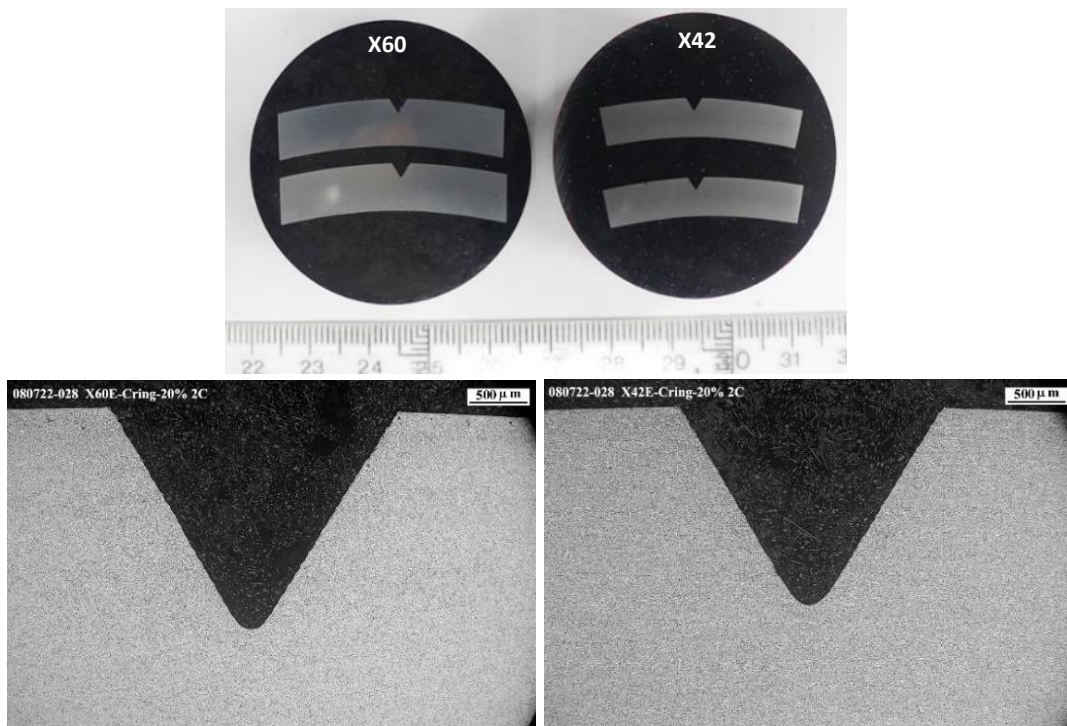
Figure 37. Resin embedded notched C-ring cross sections (up) and optical micrographs from steel grades X60 (down-left) and X42 (down-right) after the 2nd campaign

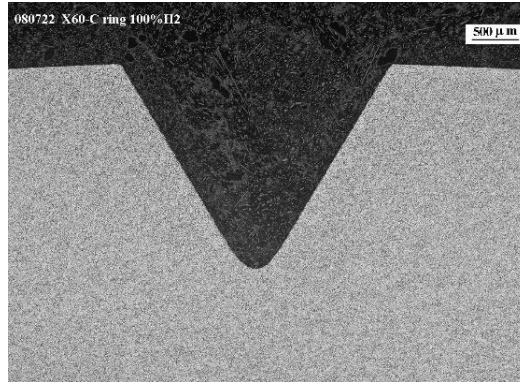
Figure 38. Optical micrograph from notched C-ring cross section of steel grade X60 after the 100 mol% H₂ campaign

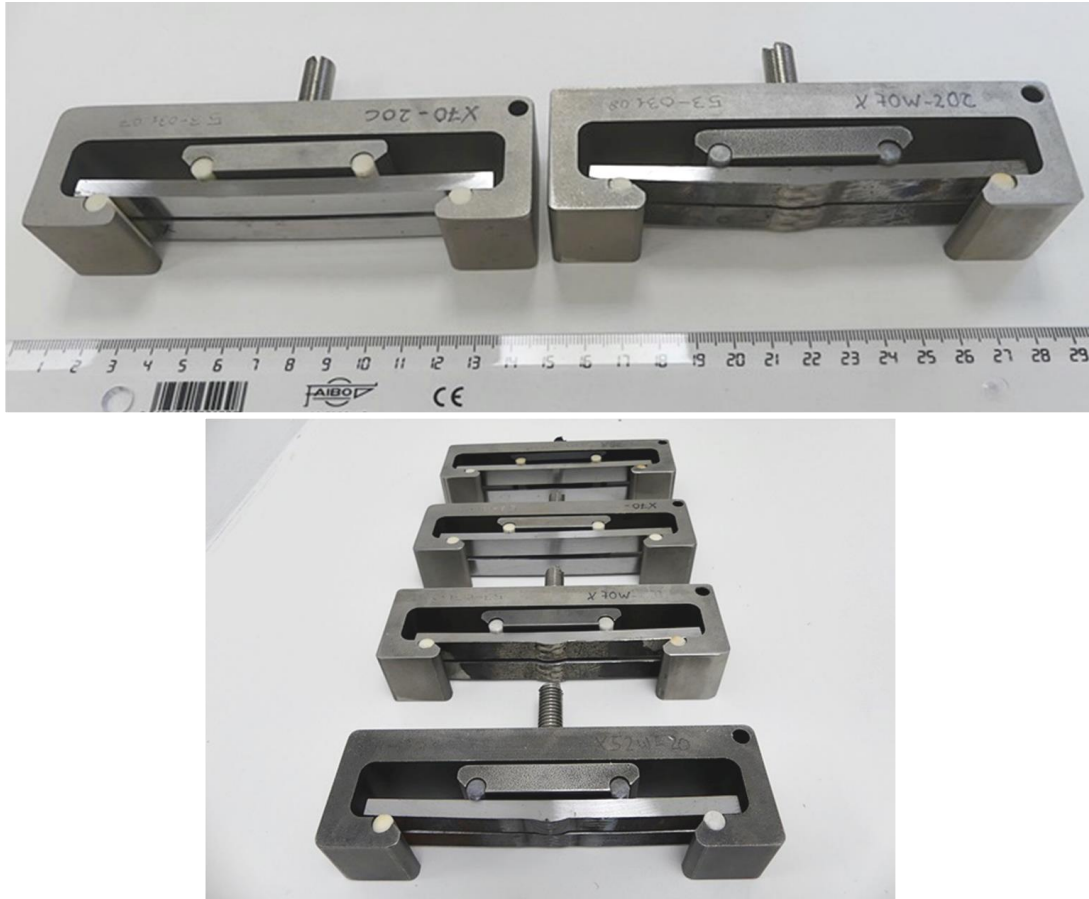
Figure 39. Tested X70 base and welded 4pb specimens supported in the loading jig after the 3rd campaign (up) and tested x70 and X52 base and welded specimens after the 100 mol% H₂ campaign

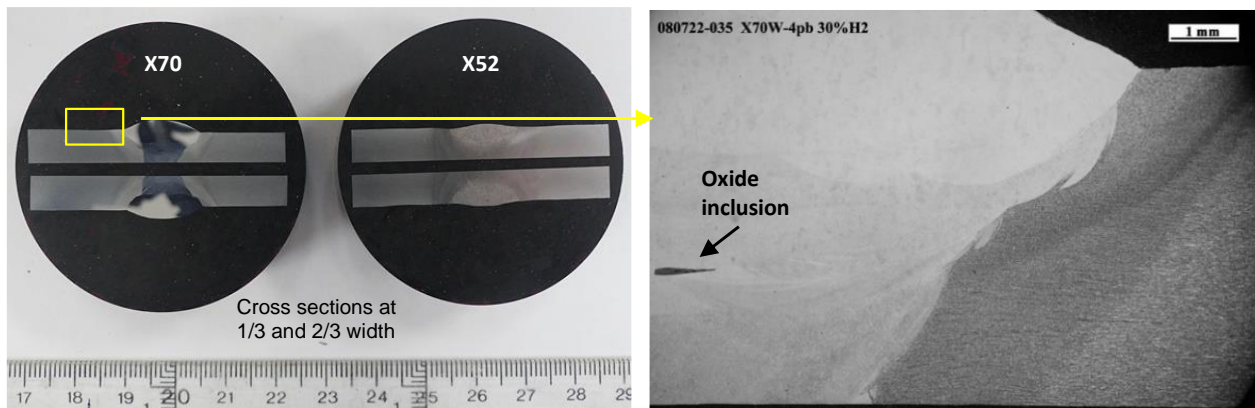
Figure 40. Resin embedded cross sections of 4pb X52 and X70 welded steel specimens (left) and optical micrograph of metallographic section of X70 welded joint (right) after the 3rd campaign

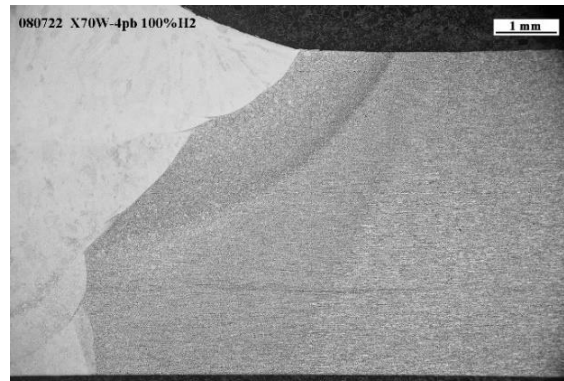
Figure 41. Optical micrograph of metallographic section of X70 welded joint after the 100 mol% H₂ experimental campaign

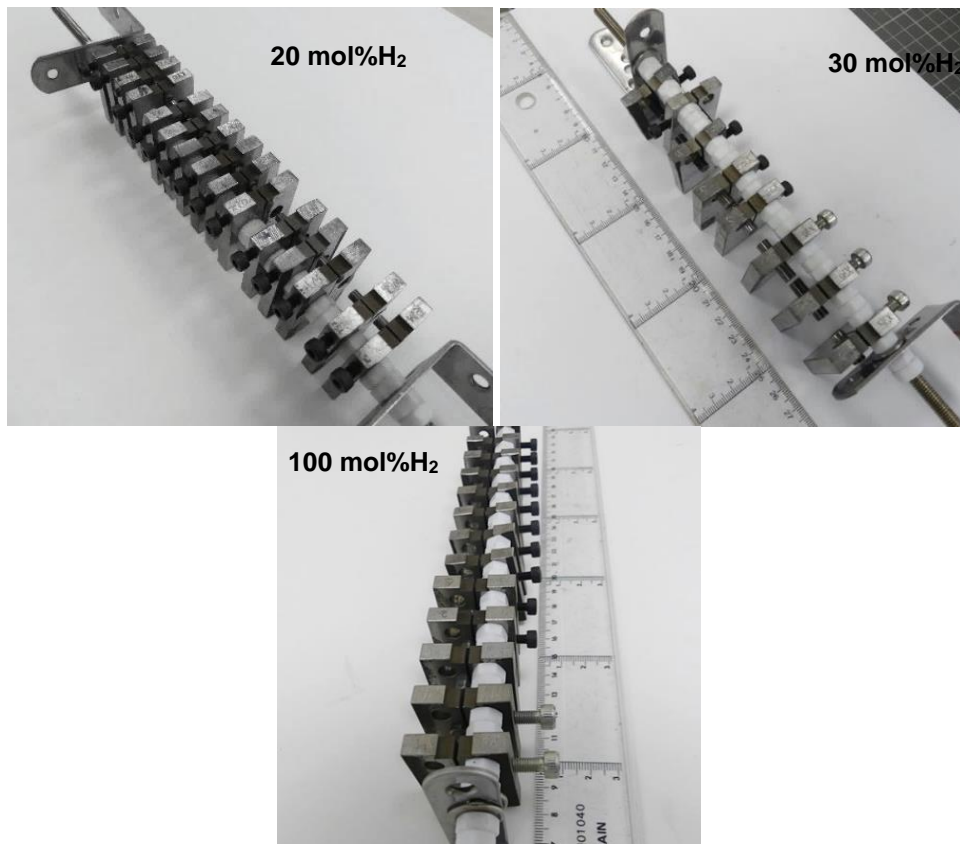
Figure 42. Rack with tested CT bolt loaded specimens in experimental campaigns 2 (top-left) 3 (top-right) and 4 (down)

Figure 42 shows the appearance of the racks with the CT-WOL specimens tested in experimental campaigns 2, 3 and 4. The CT specimens were unloaded (removing the bolt) and then heat tinted (30 min at 300 °C) and broken. The fracture surface was examined by SEM to assess if subcritical cracking occurred from the initial fatigue pre-crack. Measurements of the crack front extent were carried out in three positions and the average crack growth in hydrogen was calculated according to ASTM E1681 standard. No hydrogen crack growth was measured for any CT specimen (crack propagation < 0.25 mm). Fracture surface examination revealed the same fracture mode in the fatigue pre-crack and in the crack front (Figure 43 and Figure 44). The results for these specimens are summarised in Table 10.
