Hydrogen in Gas Grids

A systematic validation approach at various admixture levels into high-pressure grids

D4.4

Final report on systematic validation of testing loop

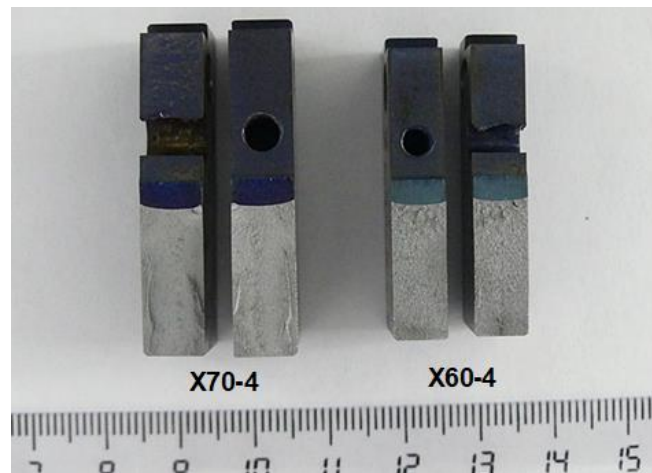
Figure 43. Heat tinted fracture surface of CT-WOL specimens after the 100 mol% H₂ campaign

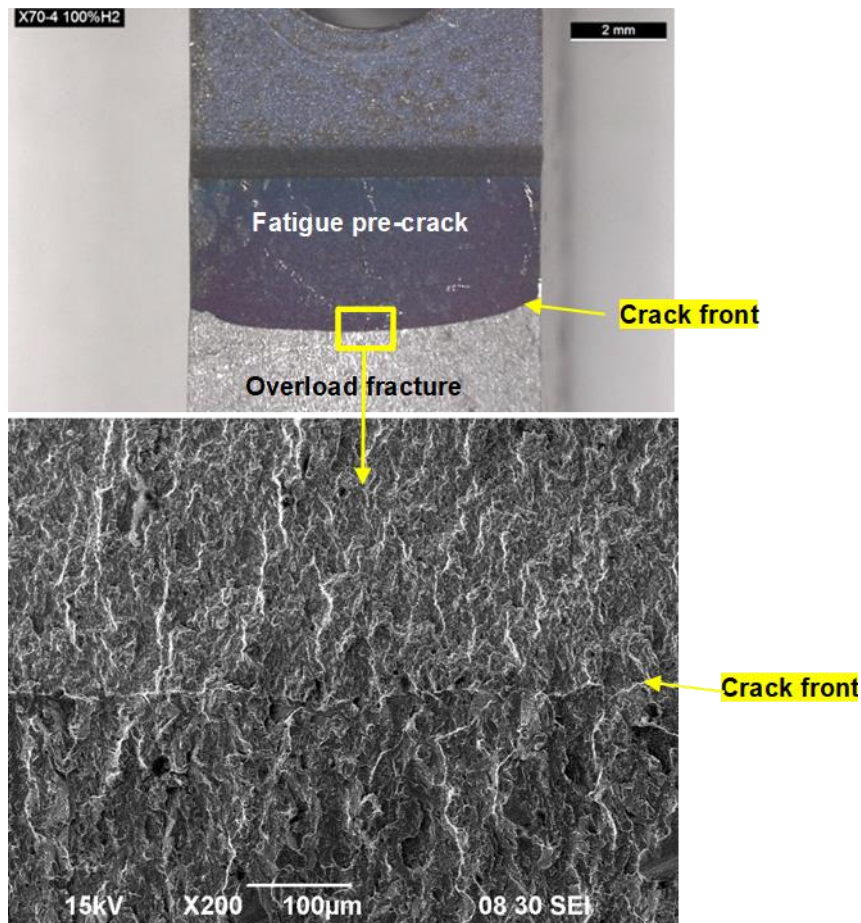
Figure 44. Heat tinted fracture surface of X70 CT-WOL specimens after 100 mol% H₂ exposure and SEM micrograph showing detail of the fatigue pre-crack surface and crack advancing front

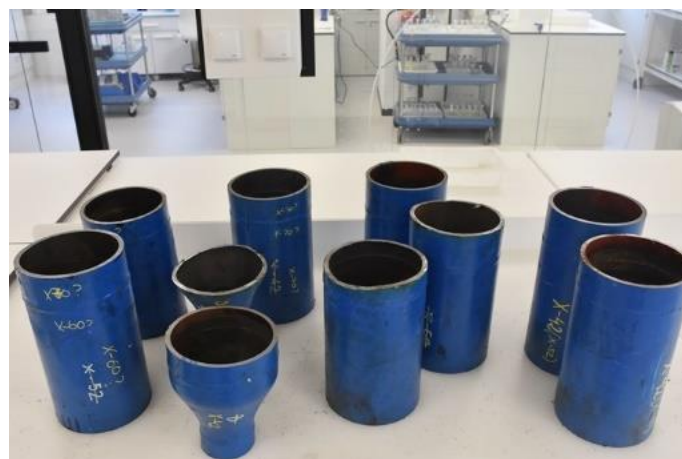
Figure 45. Aspect of the welded pipe sections delivered to Tecnia after the 100 mol% H₂ campaign

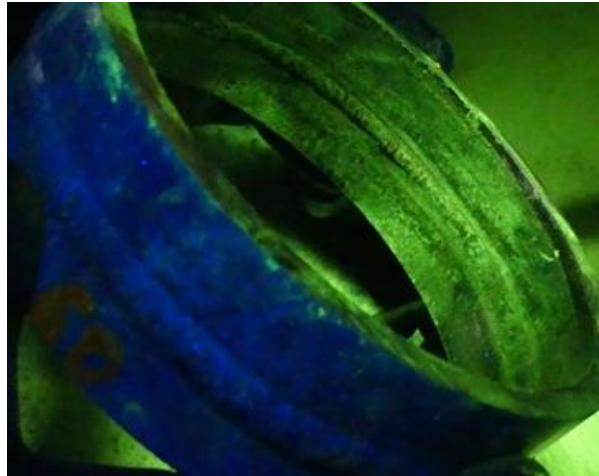
Figure 46. Magnetic particle testing of X42-X52 welded joint

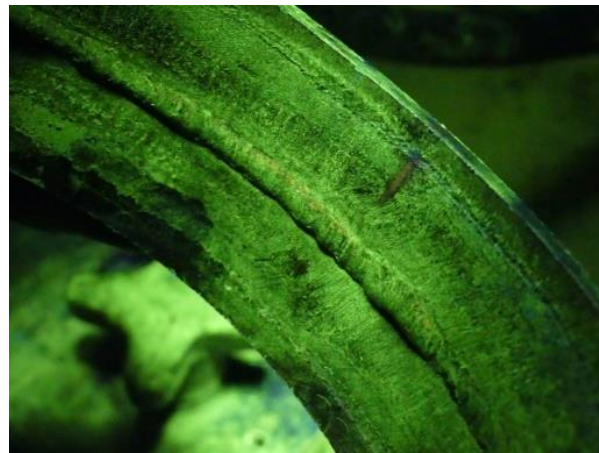
Figure 47. Magnetic particle testing of X52-X60 welded joint

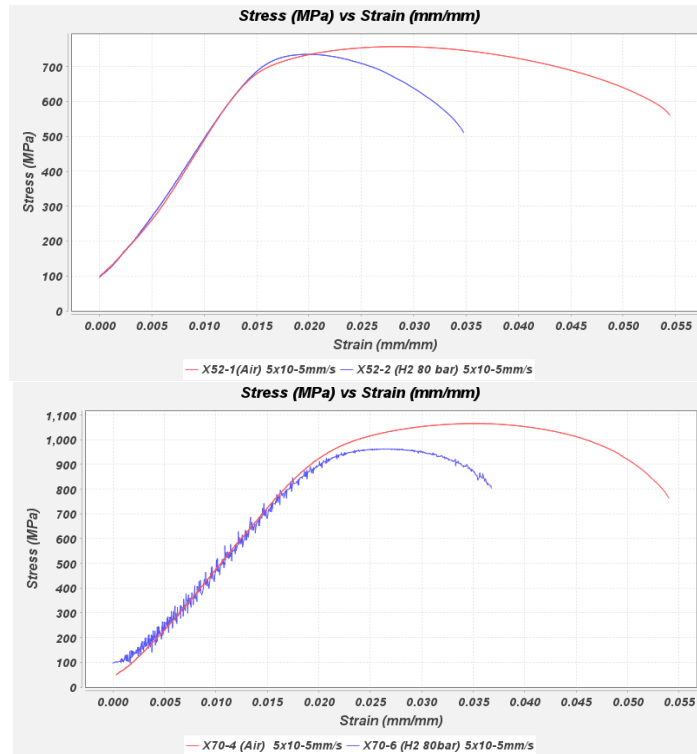
Figure 48. Stress strain curves of notched SSRT specimens tested in air and in H₂ (80 bar)

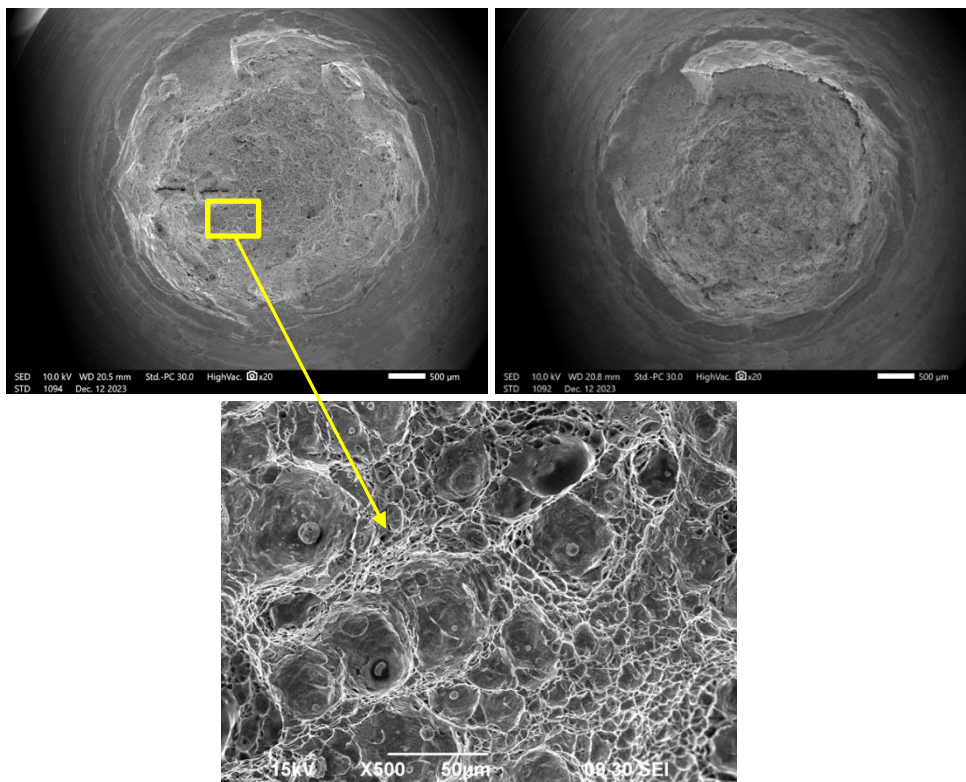
Figure 49. Electron micrographs showing fully ductile fracture surface of SSRT specimens tested in air: X52 (up-left), X60 (up-right). Numerous particles within the dimples are observed (down)

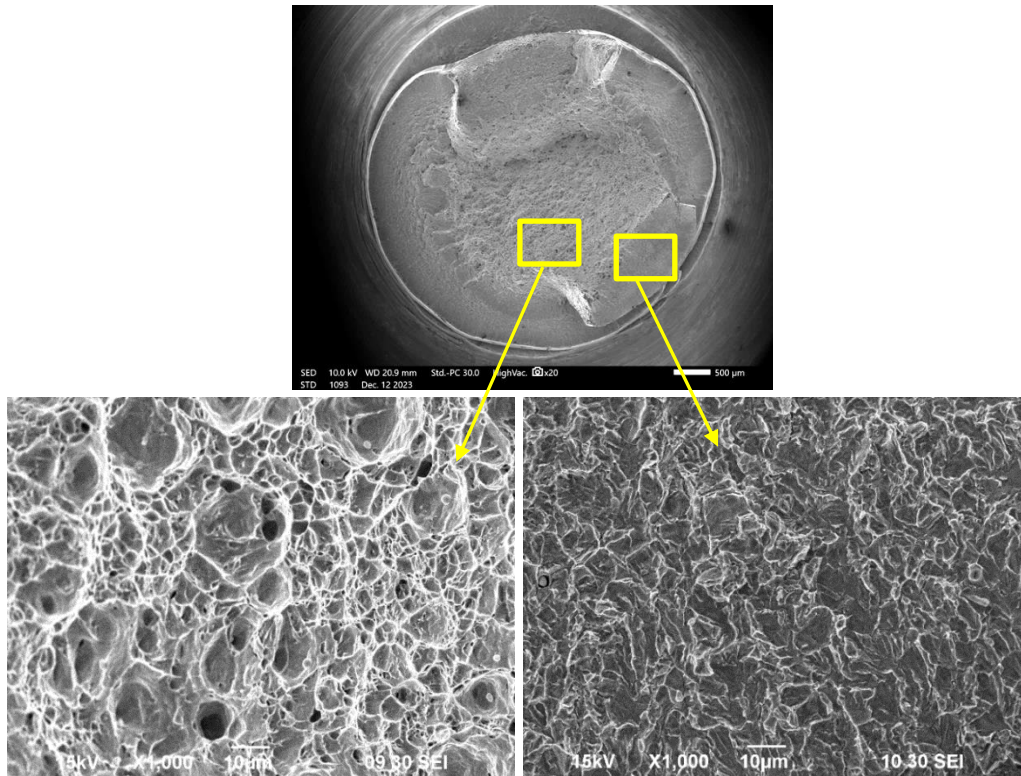
Figure 50. Electron micrographs of fracture surface of X52 SSRT specimen tested in H₂ at 80 bar, showing a central region with dimples generation (down-left) and a peripheral region with transgranular cleavage (down-right)

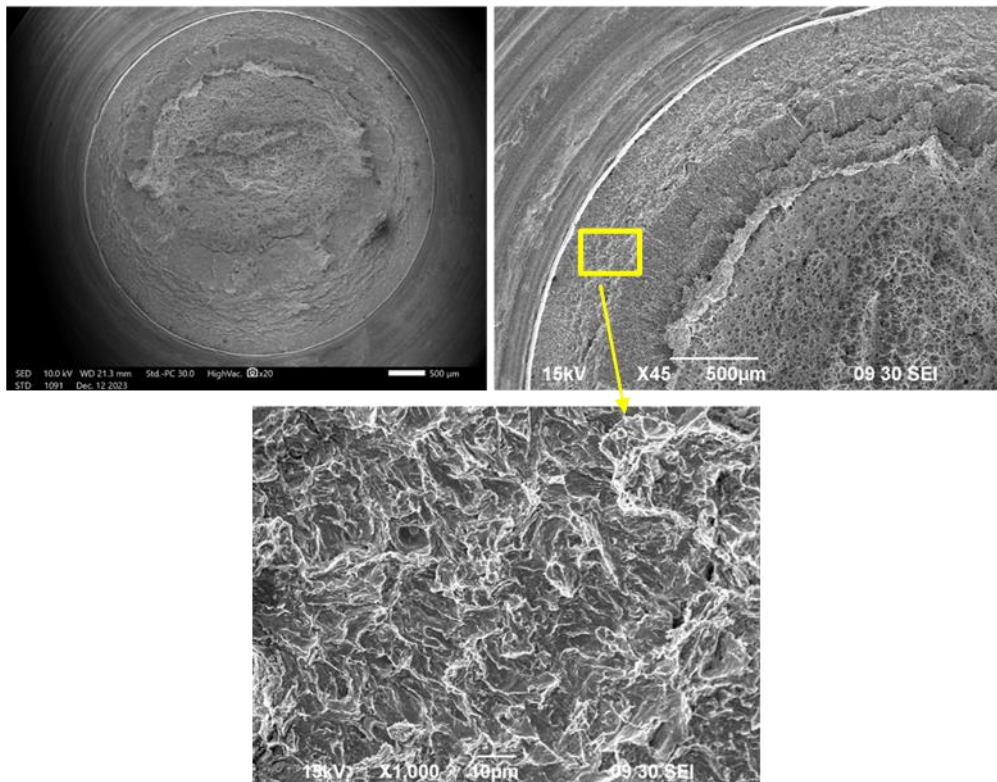
Figure 51. Electron micrographs of fracture surface of X60 SSRT specimen tested in H₂ at 80 bar (up) and detail of the peripheral region with transgranular cleavage (down)

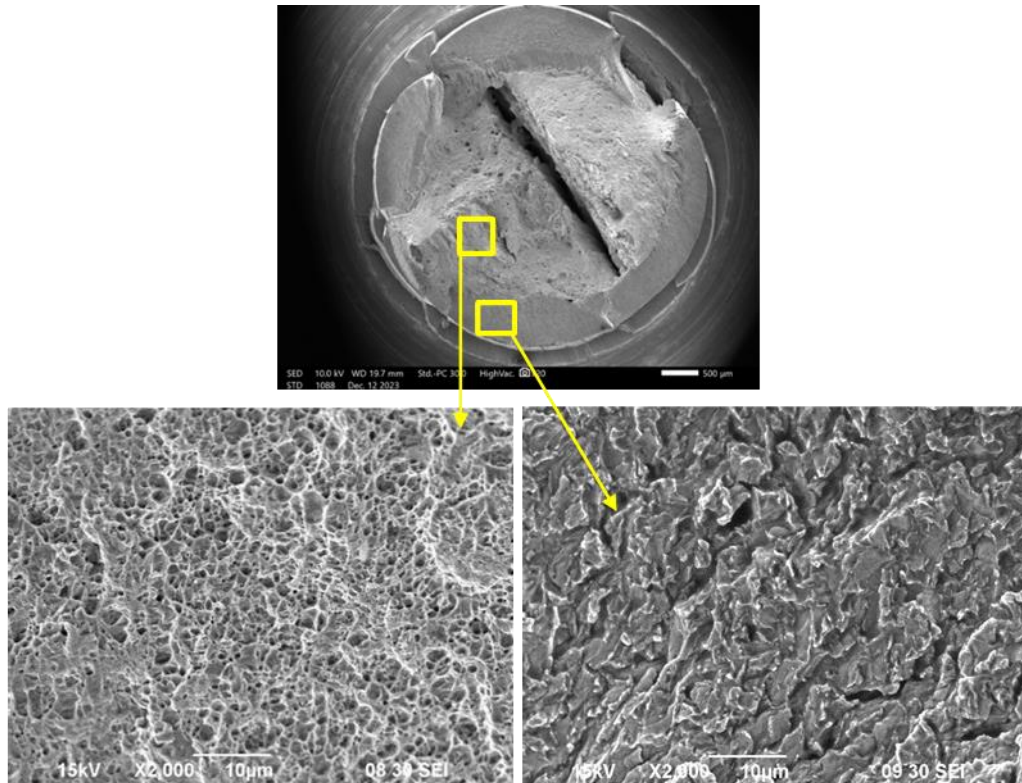
Figure 52. Electron micrographs showing fracture surface of X70 SSRT specimen tested in H₂ at 80 bar (left) and detail of the peripheral region with transgranular cleavage and secondary crack penetration
